REPORT NO. 3721  
SOUTHERN PACIFIC COMPANY  
IN RE ACCIDENT  
NEAR WEBSTER, CALIF., ON  
OCTOBER 31, 1956

Accident near Webster, Calif., on October 31, 1956, caused  
by improper handling of a locomotive crane.

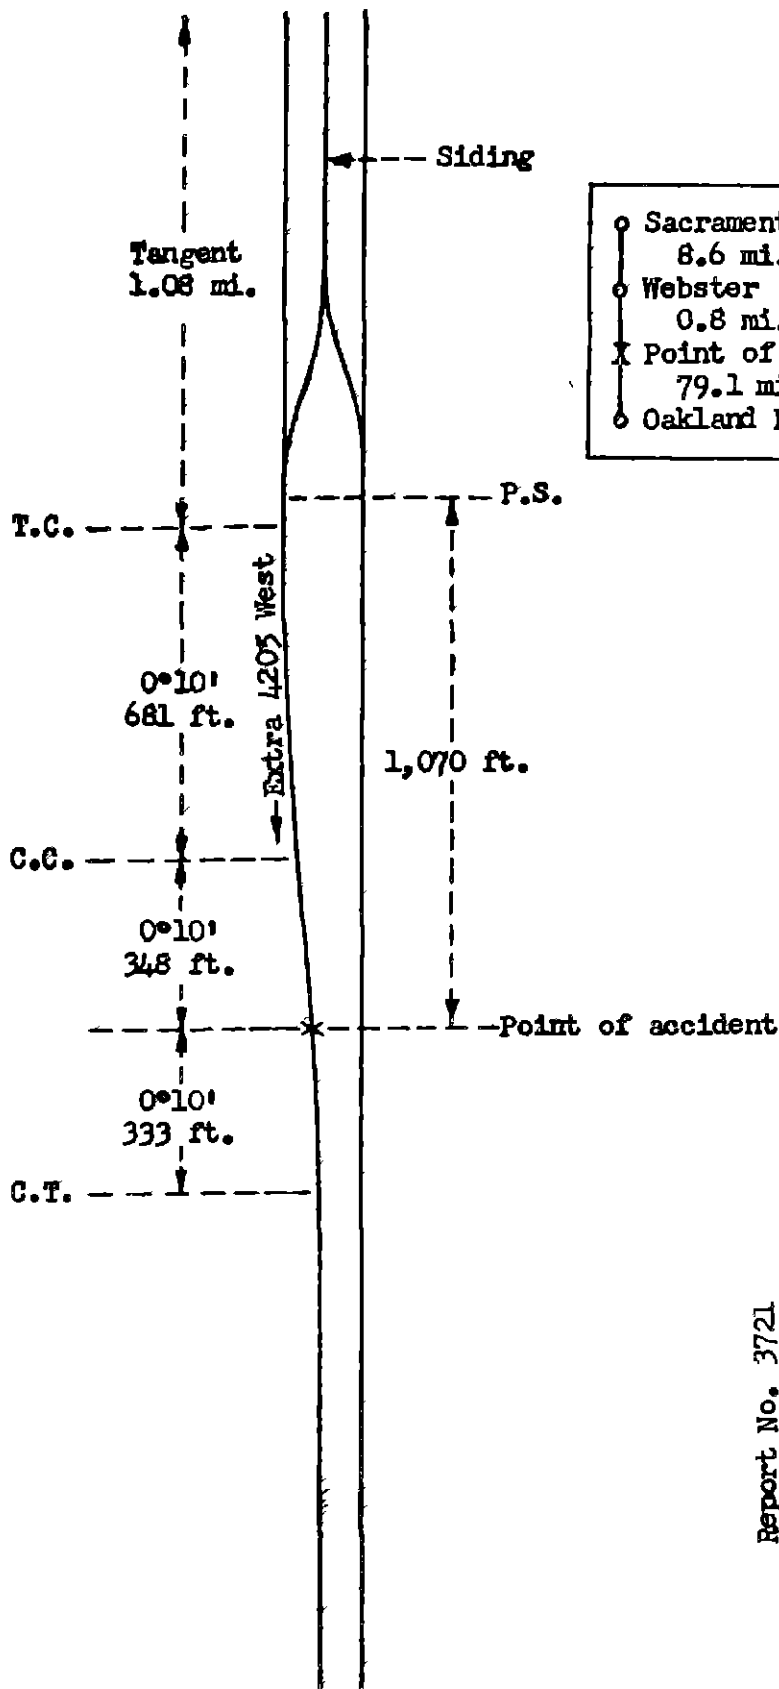
Report No. 3721  
Southern Pacific Company  
Webster, Calif.  
October 31, 1956

→ To Sacramento, Calif. →

← To Oakland Pier, Calif. ←

○	Sacramento, Calif.
○	8.6 mi.
○	Webster
○	0.8 mi.
X	Point of accident
○	79.1 mi.
○	Oakland Pier, Calif.
